Ignition Coil Housing Cracked (58/12)

Concerns: **Ignition coil**

Information: **Procedure for replacing faulty ignition coils.**

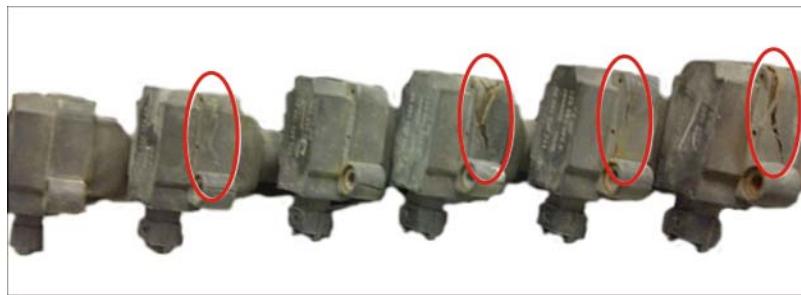
Figure 1

Cracks in the ignition coil housing (⇒ *Figure 1*) can cause corrosion, which can result in a rough-running engine and misfiring.

Action Required: If at least one ignition coil is diagnosed as faulty (see damage comparison ⇒ *Figure 1*), all ignition coils must be replaced.

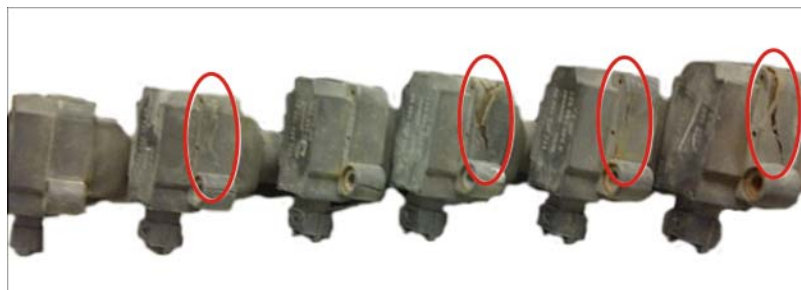
Figure 1

Cracks in the ignition coil housing (⇒ *Figure 1*) can cause corrosion, which can result in a rough-running engine and misfiring.

Action Required: If at least one ignition coil is diagnosed as faulty (see damage comparison ⇒ *Figure 1*), all ignition coils must be replaced.

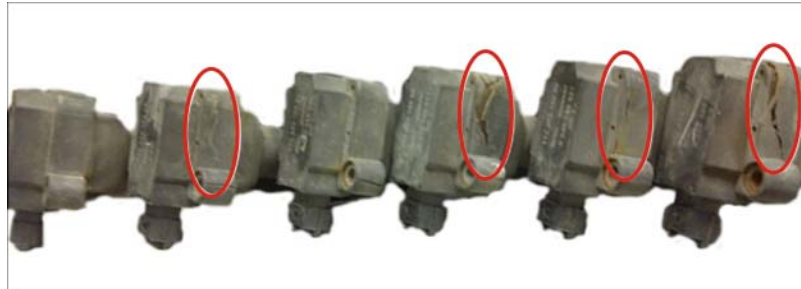
Figure 1

Cracks in the ignition coil housing (\Rightarrow *Figure 1*) can cause corrosion, which can result in a rough-running engine and misfiring.

Action Required: If at least one ignition coil is diagnosed as faulty (see damage comparison \Rightarrow *Figure 1*), all ignition coils must be replaced.

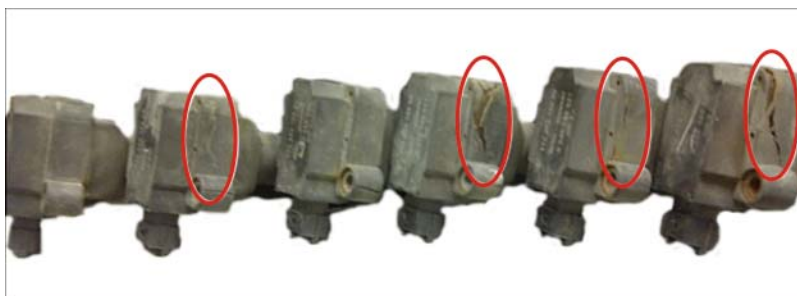
Figure 1

Cracks in the ignition coil housing (⇒ *Figure 1*) can cause corrosion, which can result in a rough-running engine and misfiring.

In the event of a complaint about a rough-running engine and misfiring, the ignition coils must be checked visually for signs of damage.

If at least one ignition coil is diagnosed as faulty (see damage comparison ⇒ *Figure 1*), **all ignition coils** must be **replaced**.

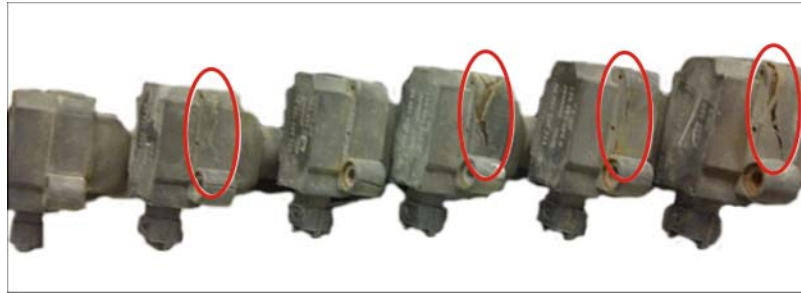
Figure 1

Cracks in the ignition coil housing (⇒ *Figure 1*) can cause corrosion, which can result in a rough-running engine and misfiring.

Action Required: In the event of a complaint about a rough-running engine and misfiring, the ignition coils must be checked visually for signs of damage.

If **at least one ignition coil is diagnosed as faulty** (see damage comparison ⇒ *Figure 1*), **all ignition coils** must be **replaced**.
